MISCELLANEOUS PAPER 5-65-27

MISSILE BASES: DESIGN AND CONSTRUCTION PROBLEMS

December 1968

Conducted by
U. S. Army Engineer Waterways Experiment Station
CORPS OF ENGINEERS
Vicksburg, Mississippi

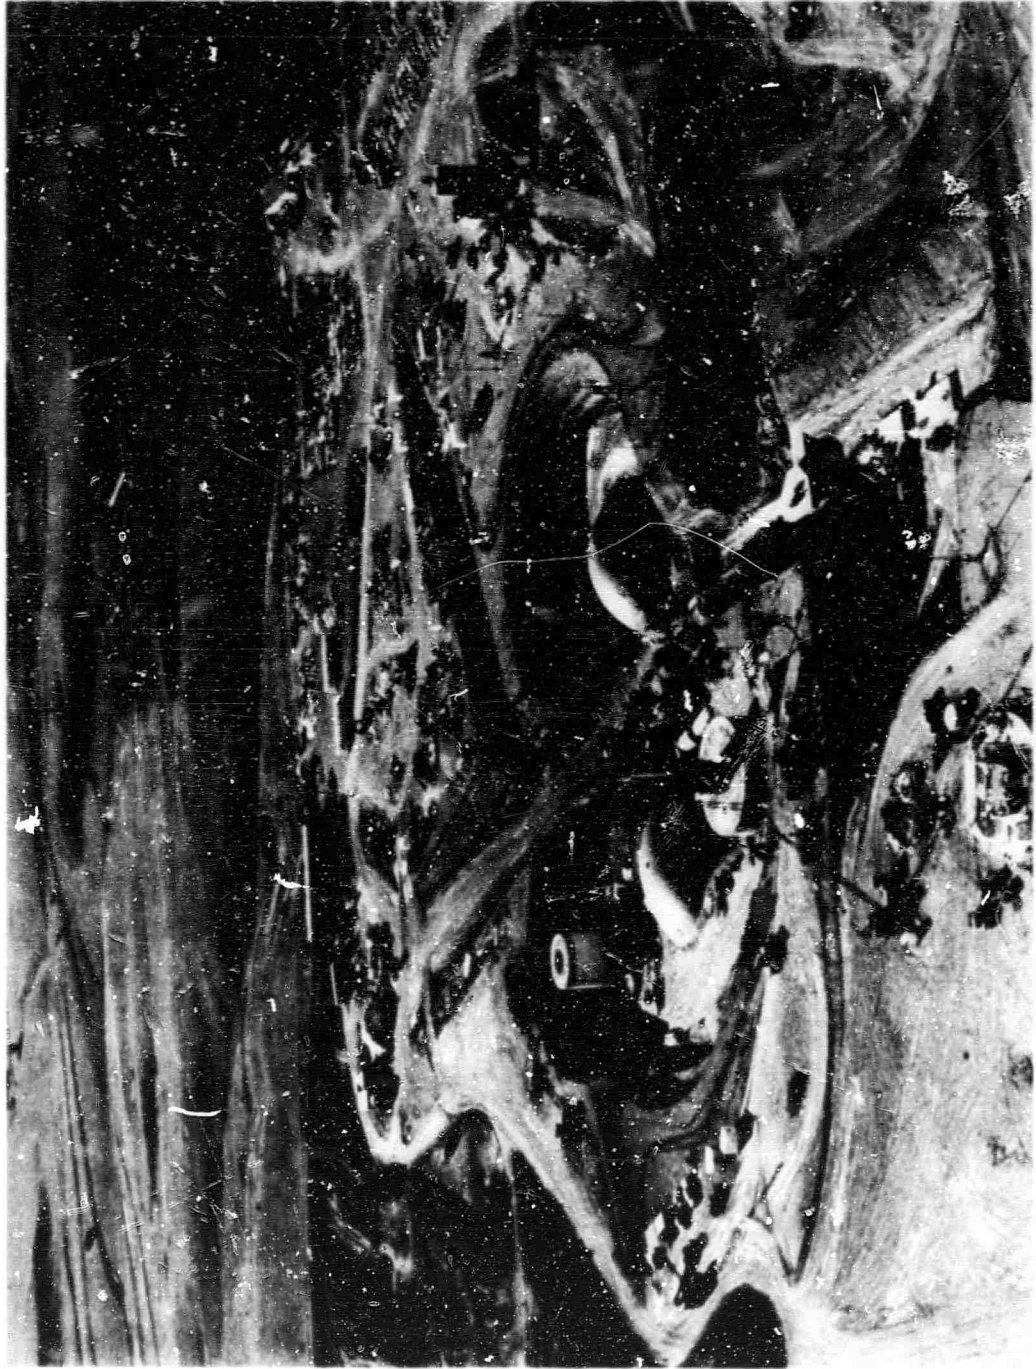
Fig. 1. Aerial view of Titan I complex

In order to gain a better idea of missile-base construction work, some illustrations are included which demonstrate why rather severe problems in design and/or construction developed. Figure 1 is an aerial view of a Titan I complex. The view shows the structures partially backfilled, and illustrates the steep back slopes and the relatively confined construction area involved. Figure 2 is a cutaway of the Atlas F configuration showing the location of the major features of construction with respect to the ground surface. Figure 3 is a cutaway of a Minuteman launch facility showing the relation of the launch equipment room (LER) (doughnut-shaped structure around the missile shaft), access shaft (AS), and launch equipment building (LEB). It will be noted that very little

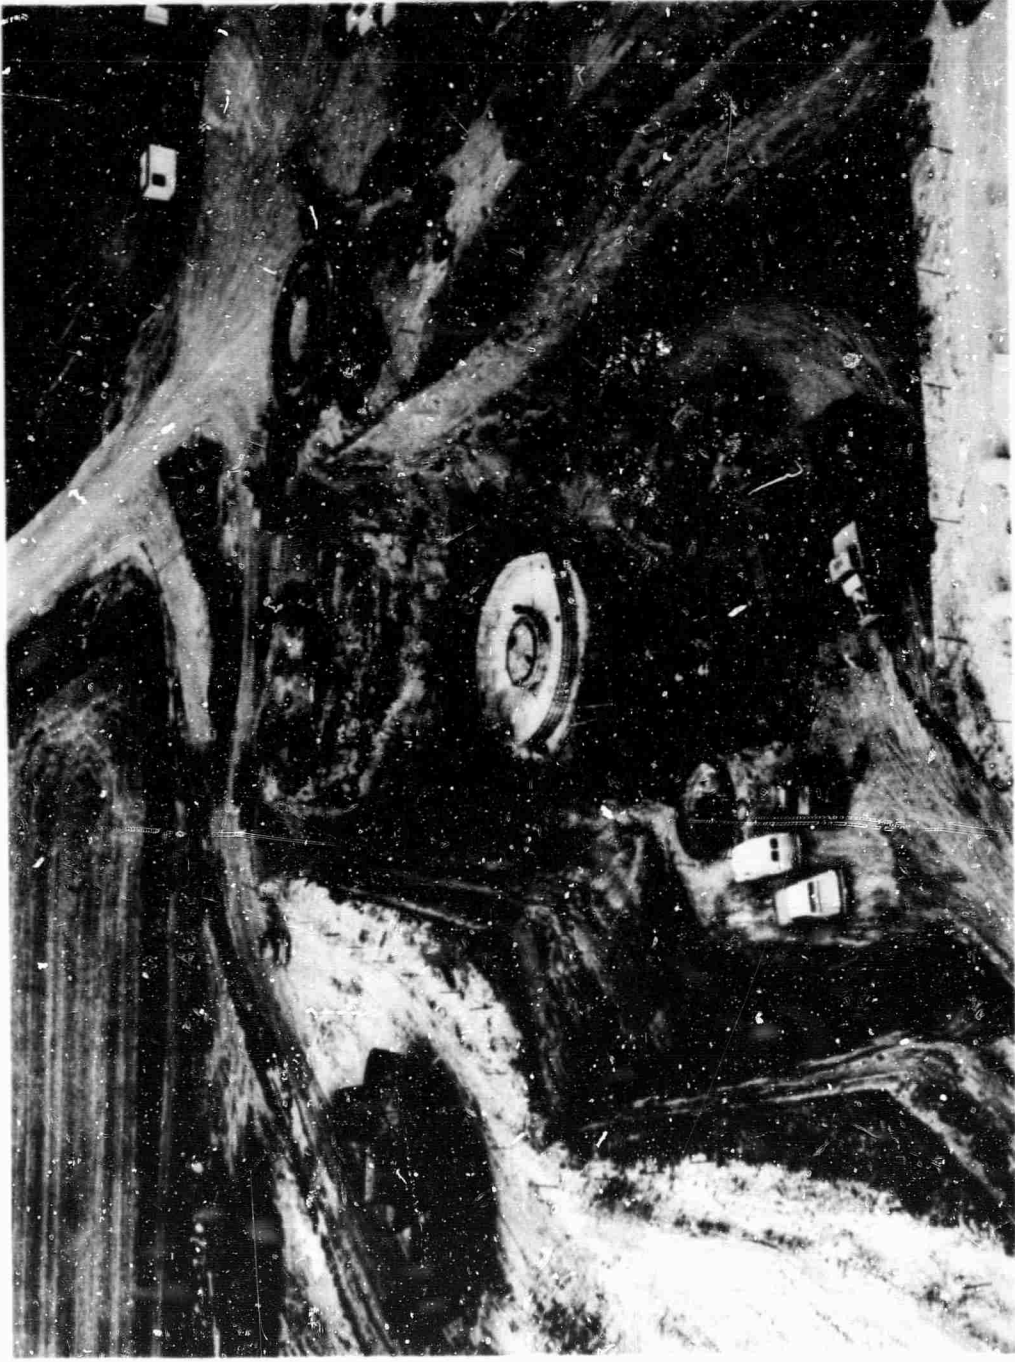
Fig. 9. Minuteman excavation; wet base-level due to seepage from toe of slope

Excavation. The lack of adequate plans and specifications for individual facilities, as far as excavating and dewatering were concerned, can be considered as the basic cause of many difficulties. Excavation, in general, both in open cut and shaft, posed relatively few problems except in those sites where unanticipated difficulties were produced by groundwater or where improper blasting techniques were used. It was the exception rather than the rule for groundwater problems to be properly evaluated in advance of construction and for proper construction techniques to be utilized to avoid difficulty. In fact, at numerous facility sites, it was not possible to develop proper construction techniques due to the absence of a properly designed and installed dewatering system. Improper handling of groundwater resulted in sloughing of slopes that were excavated too steep; development of high pore pressures in cohesionless materials around shafts, causing excessive lateral pressures and sometimes outright failures; slippage of rock, shale blocks, and soil into shafts; and development of quick conditions in areas being excavated due to seepage into the completed excavation. Figure 7 shows an Atlas facility with excavation to the basic level; water problems are being experienced from runoff into the excavation and from seepage at the toe of the excavation. Figure 8 is a view looking into an Atlas F silo showing a wet, mucky condition at the bottom of the excavation. Figures 9, 10, 11, and 12 are views of Minuteman excavations. Figure 9 shows a wet base-level excavation due to seepage from the toe of the slope. Figure 10 shows water piping from the toe of the excavation and sloughing soil. Figure 11 shows the completed excavation for an LEB structure, the bottom of which has become liquefied due to upward seepage. Figure 12 shows

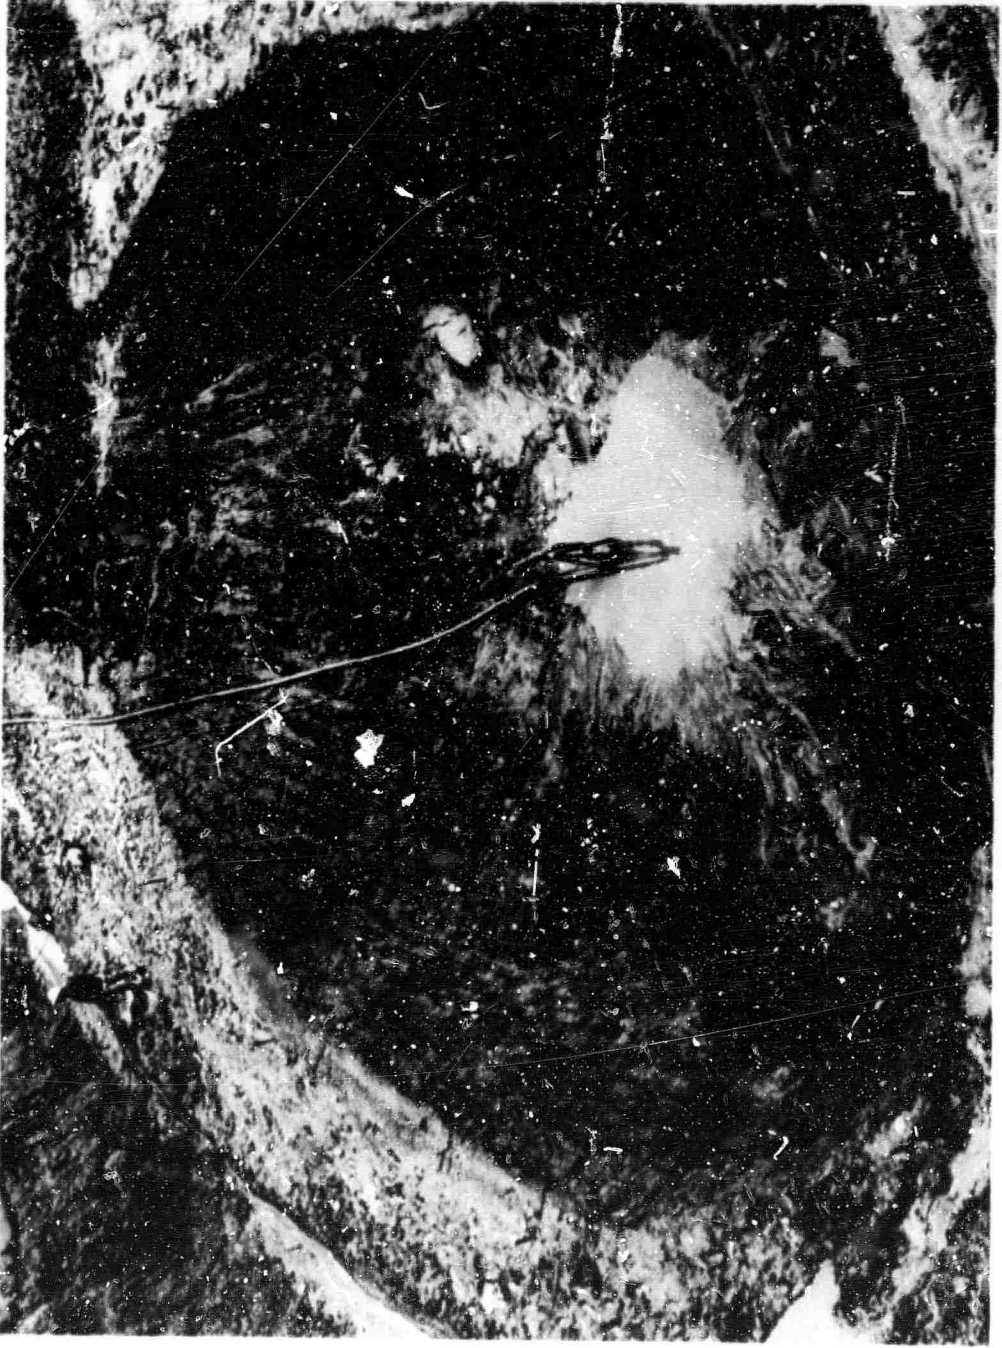
Fig. 11. Completed excavation for Minuteman launch equipment building

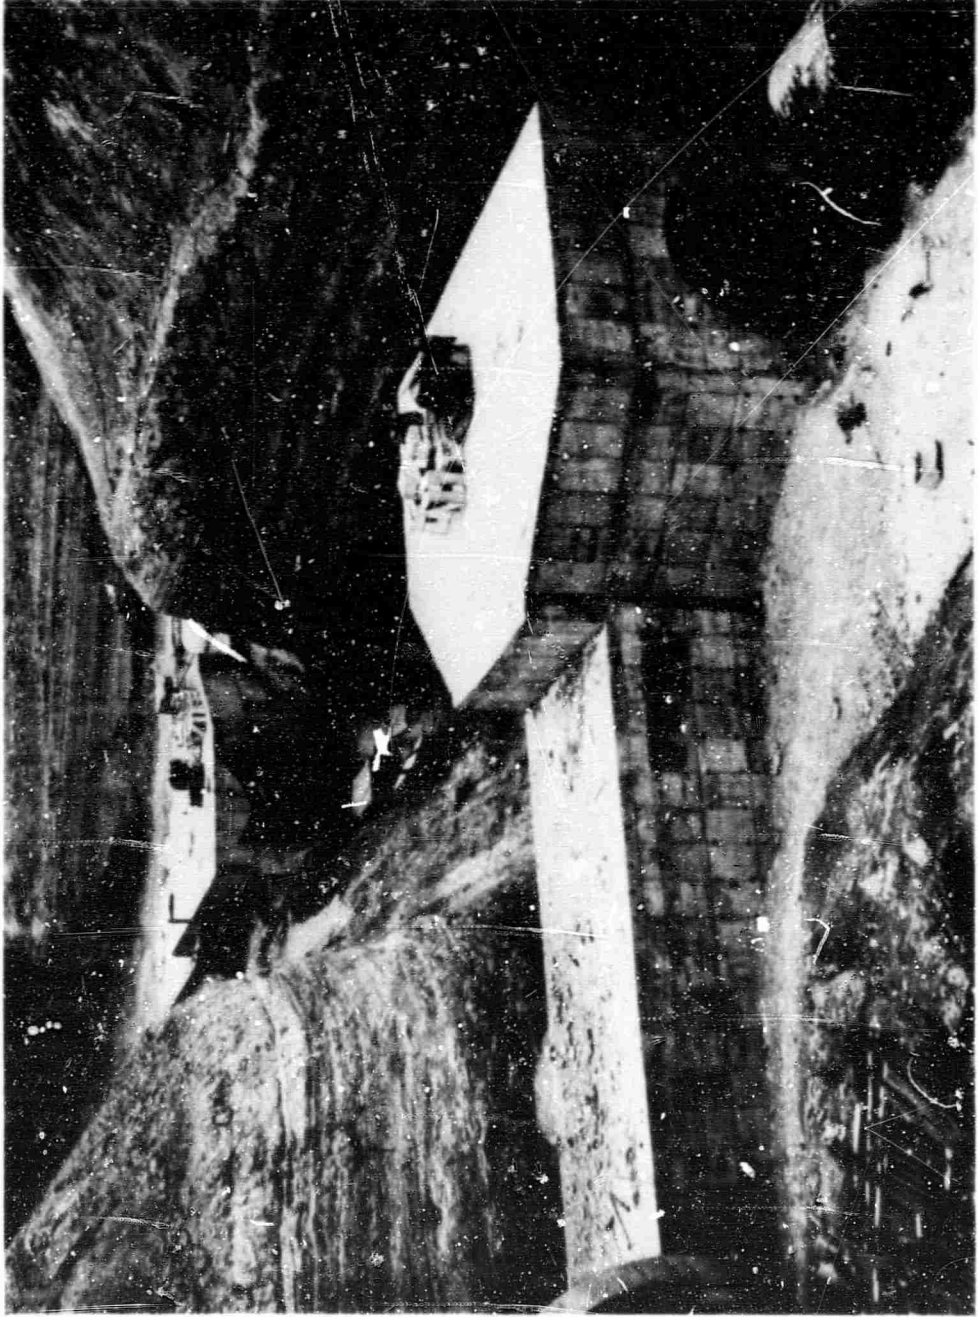
Fig. 13. Backfill around concrete blastlock structure and below haunch of steel-plate tunnel, Titan I facility
